Comparison of the Corrosion Behavior of High Strength Aluminum Alloys after Exposure to ASTM B117 Environment

S.N. Grieshop*, R.G. Buchheit*

*Ohio State University, Department of Materials Science and Engineering, 477 Watts Hall, Columbus, OH.

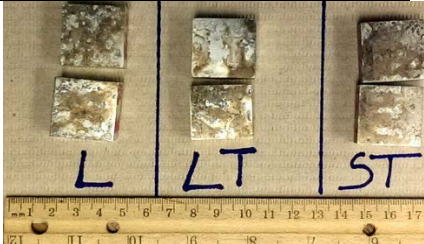
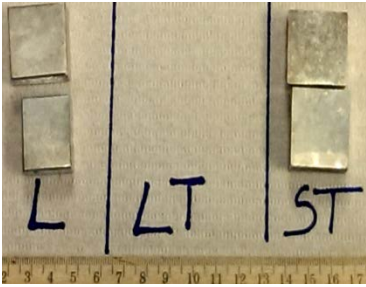
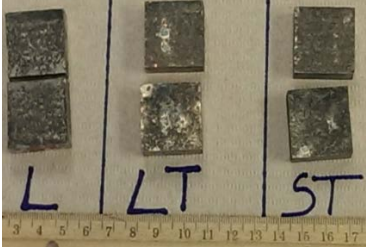
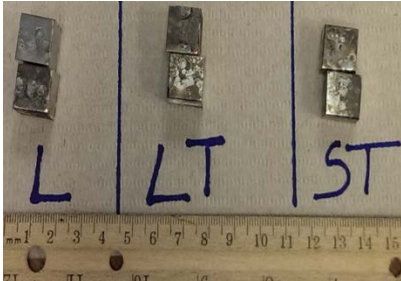
Table 2: Results for the Visual Inspection of Samples Tested for 72 and 120 Hours in B117

Analysis of the surfaces of the samples after cleaning by the nitric acid solution was invaluable to discovering the differences in corrosion behavior between the five alloys studied. Images of the samples are presented in Table 2. It is apparent that the surface of the samples changes depending on the alloy and exposure conditions. All samples except 2099-T3 featured a

difficult to remove corrosion product on the surface of the sample after cleaning. It should be noted that AA7050 and AA2524 featured less corrosion product remaining after nitric acid cleaning. This may be related to the fact that these alloys are to feature less large particles, like AA2099.

The corrosion product on the surface for AA7075 was the most difficult to remove corrosion product, with the resulting residue forming a dark brown product obscuring parts of the surface. 2024-T3 and 2524-T3 corrosion product was easier to remove, with the resulting corrosion residue retaining a whitish color on the sample surface. In contrast, AA2099-T3 had almost all corrosion product removed from the surface of the sample after cleaning, with only a slight film on the sample surface remaining.

The differences in the surface conditions of the sample after removal of the corrosion product speak to the differences in corrosion behavior of each sample. AA2099-T3 does not form such a rough, difficult to remove corrosion product on exposure to an adverse environment, indicating that this alloy has a different corrosion response than the other alloys. It is well known in the literature that precipitates in aluminum –lithium-copper alloys are smaller than those found in other high strength aluminum alloys [5] . This provides fewer sites for attack, which would provide fewer sites to generate corrosion product. The corrosion product composition may also play a role in the difference between 2099-T3 and the other alloys tested, but this has to be further researched.
